PERFORMANCE TEST REPORT

**PRODUCT TYPE: 3' x 8' Single Inswing Hardwood Door
with Side Lites and Half Circle Transom**

Report No.: 64141.01-801-44
Test Dates: 04/04/06
Through: 07/25/06
Report Date: 08/18/06
Expiration Date: 07/25/10

Project Summary: Architectural Testing, Inc. (ATI) was contracted by Glass Craft Door Corporation to perform testing on a 3' x 8' inswing hardwood door with two side lites and a half circle transom. Test specimen description and results are reported herein.

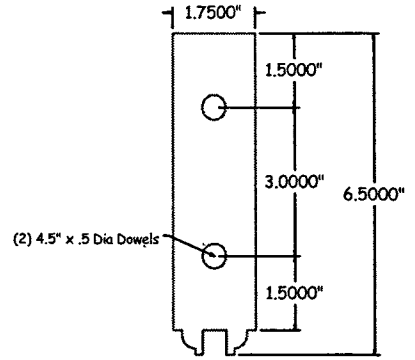
Top Rail

Leaf Construction: The door leaf was constructed of 1-3/4" thick hardwood and utilized a glued cove and bead joint, reinforced with 1/2" diameter by 4-1/2" long wood dowels. Two dowels were located at the top and middle rail to stile joint, and four dowels were located at the bottom rail to stile joint.

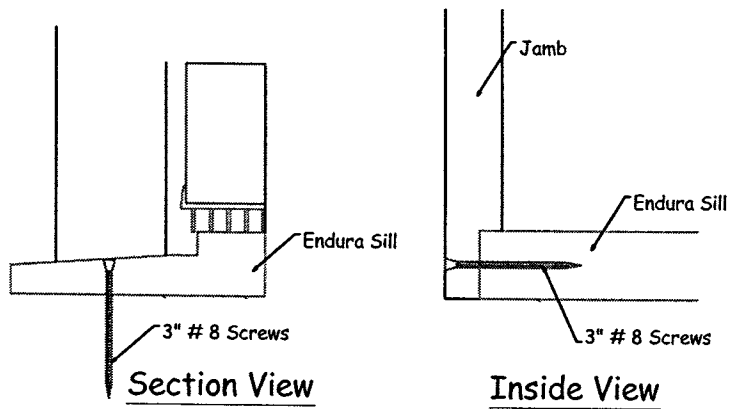
A Threshold

Frame Construction: The doorframe was constructed of 4-5/8" by 1-1/4" hardwood head and jambs, and 3-5/8" by 2-5/8" mullions and included an adjustable extruded aluminum and composite threshold. The head and jambs were kerfed to accept the weatherstripping. The corners were coped and butted and secured with two #8 x 1-1/2" and five #8 x 3" screws at the threshold; and four #8 x 1-1/2" and two #8 x 3" screws at the head. The mullions were attached with five #8 x 3" screws through the head and the threshold.

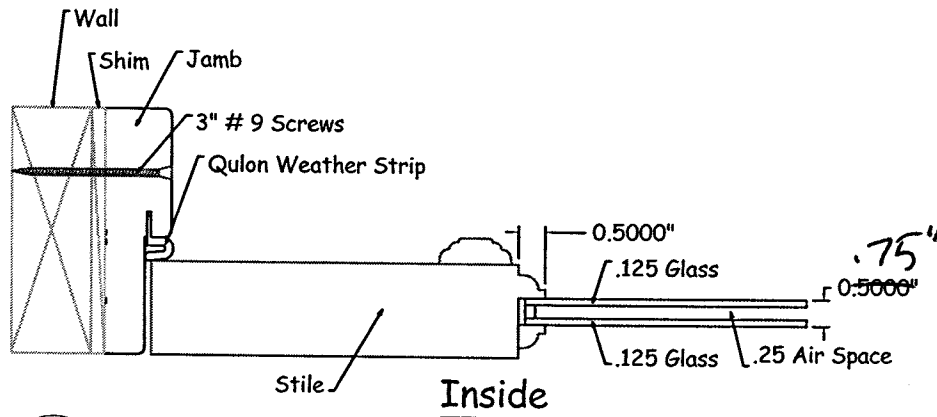
C Glass

Glazing Type: Sealed insulating glass comprised of 1/8" thick tempered glass at the exterior and 1/8" thick tempered decorative textured glass at the interior. A 1/2" aluminum spacer system was used providing 3/4" overall thickness.

Glazing Details: Interior glazed with double sided butyl tape and a nailed-on wood glazing bead secured by 1" long by 0.040" by 0.050" rectangular shank brad nails with 0.050" by 0.080" heads (18 gauge brad nail) 1" from each corner and on 6" spacing thereafter.

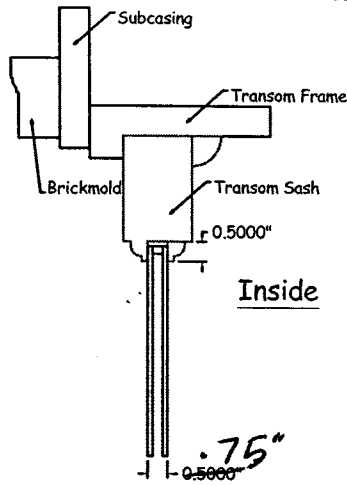
G Transom Head

Frame Construction: The frame was constructed of 4-1/2" by 3/4" hardwood. The corners were secured with two #8 x 3" wood screws.

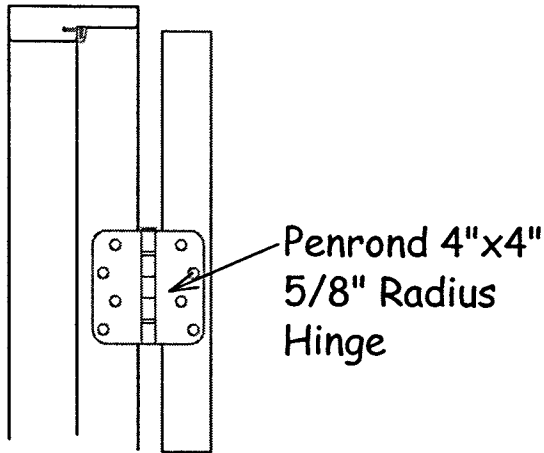
H Door Hinge

Hardware: One Schlage F-300 Series single-point lockset 36" on center from bottom of the leaf and one Schlage deadbolt located 41-5/8" on center from the bottom of the leaf. Four 4" butt type hinges fastened to each leaf with four #8 x 3" screws. Each hinge was secured to the jamb with two #8 x 3" screws and two #8 x 1" flat head screws. The hinges were located at 9-1/8", 34-1/2", 59-1/2" and 84-3/4" on center from the top of the jamb. Surface bolts were attached to the top and bottom of the leaf with four #10 x 1" flat head machine screws with a 1-1/2" long blind nut. Strike plates for the surface bolts were attached to the head with two #8 x 3" screws and to the threshold with two #10 x 3" sheet metal screws.

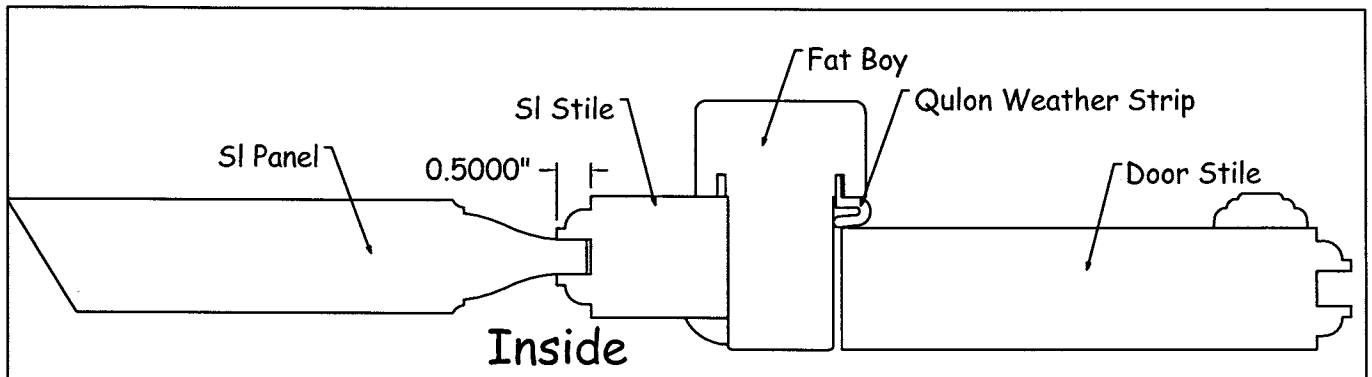
J Sidelite Panel

Panel Construction: The panel was constructed of 1-3/4" thick hardwood and utilized a glued cove and bead joint, reinforced with #8 x 3" screws. Two screws were located at the stile to top rail and stile to lock rail joints. Four screws were located at the stile to bottom rail joints. The side lite was secured to the mullions with eight #8 x 3" screws, 5" from the ends of the mullion and on 12" spacing. The side lite was secured to the frame with eight #8 x 3" screws, 5" from the ends of the jamb and on 12" spacing. Additional fastening was provided by 1/2" quarter round trim fastened by 1-1/4" long 0.040" by 0.050" rectangular shank brad nails with a 0.050" by 0.080" head (18 gauge brad nail) 1" from each corner and on 6" spacing.
