PERFORMANCE TEST REPORT

GLASS CRAFT DOOR CORPORATION

**PRODUCT TYPE: 6' x 8' Double Inswing Hardwood Door
with Half Circle Transom**

Report No.: 64137.01-801-44
Test Dates: 04/04/06
Through: 07/07/06
Report Date: 08/08/06
Expiration Date: 07/07/10

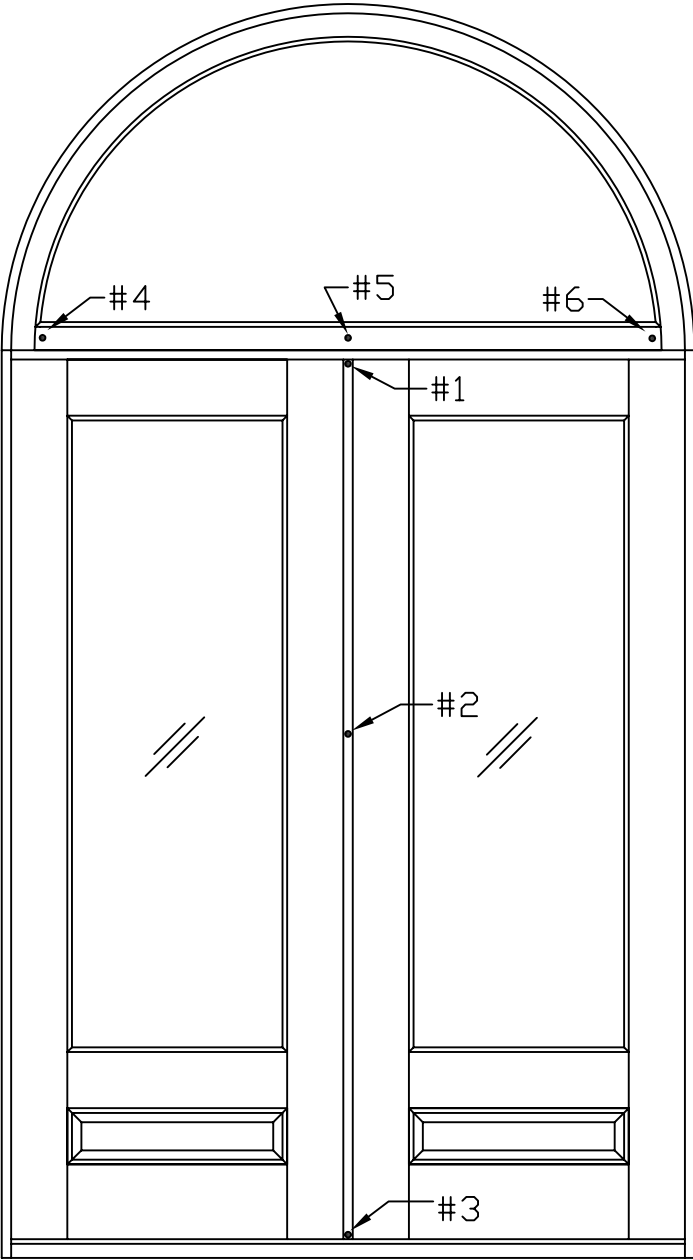
SKETCH #1

Note: See ATI Sketch #1 for indicator locations.

<u>Indicator Number</u>			Net
	1	2	3	
Uniform Load Deflection per ASTM E 330 (Deflections were taken on the astragal)				
36.2 psf (positive) (load held for 30 seconds)	0.41"	0.92"	0.53"	0.45"
45.7 psf (negative) (load held for 27 seconds)	0.45"	1.10"	0.78"	0.49"

<u>Indicator Number</u>			Net
	4	5	6	
Uniform Load Deflection per ASTM E 330 (Deflections were taken on the transom sill)				
36.2 psf (positive) (load held for 30 seconds)	0.12"	0.29"	0.15"	0.16"
45.7 psf (negative) (load held for 27 seconds)	0.19"	0.30"	0.22"	0.10"

<u>Indicator Number</u>			Net
	1	2	3	
Uniform Load Structural per ASTM E 330 (Permanent sets were taken on the astragal)				
54.3 psf (positive) (load held for 10 seconds)	0.08"	0.19"	0.29"	0.18"
68.6 psf (negative) (load held for 10 seconds)	0.01"	0.35"	0.88"	0.10"

<u>Indicator Number</u>			Net
	4	5	6	
Uniform Load Structural per ASTM E 330 (Permanent sets were taken on the transom sill)				
54.3 psf (positive) (load held for 10 seconds)	0.02"	0.02"	0.02"	<0.01"
68.6 psf (negative) (load held for 10 seconds)	0.06"	0.04"	0.07"	<0.01"
